KSC Ice/Frost/Debris Assessment For Space Shuttle Mission STS-29R

Charles G. Stevenson
NASA/Kennedy Space Center

KSC ICE/FROST/DEBRIS ASSESSMENT
FOR
SPACE SHUTTLE MISSION
STS-29R
MARCH 13, 1989

Approved:
April 30, 1989

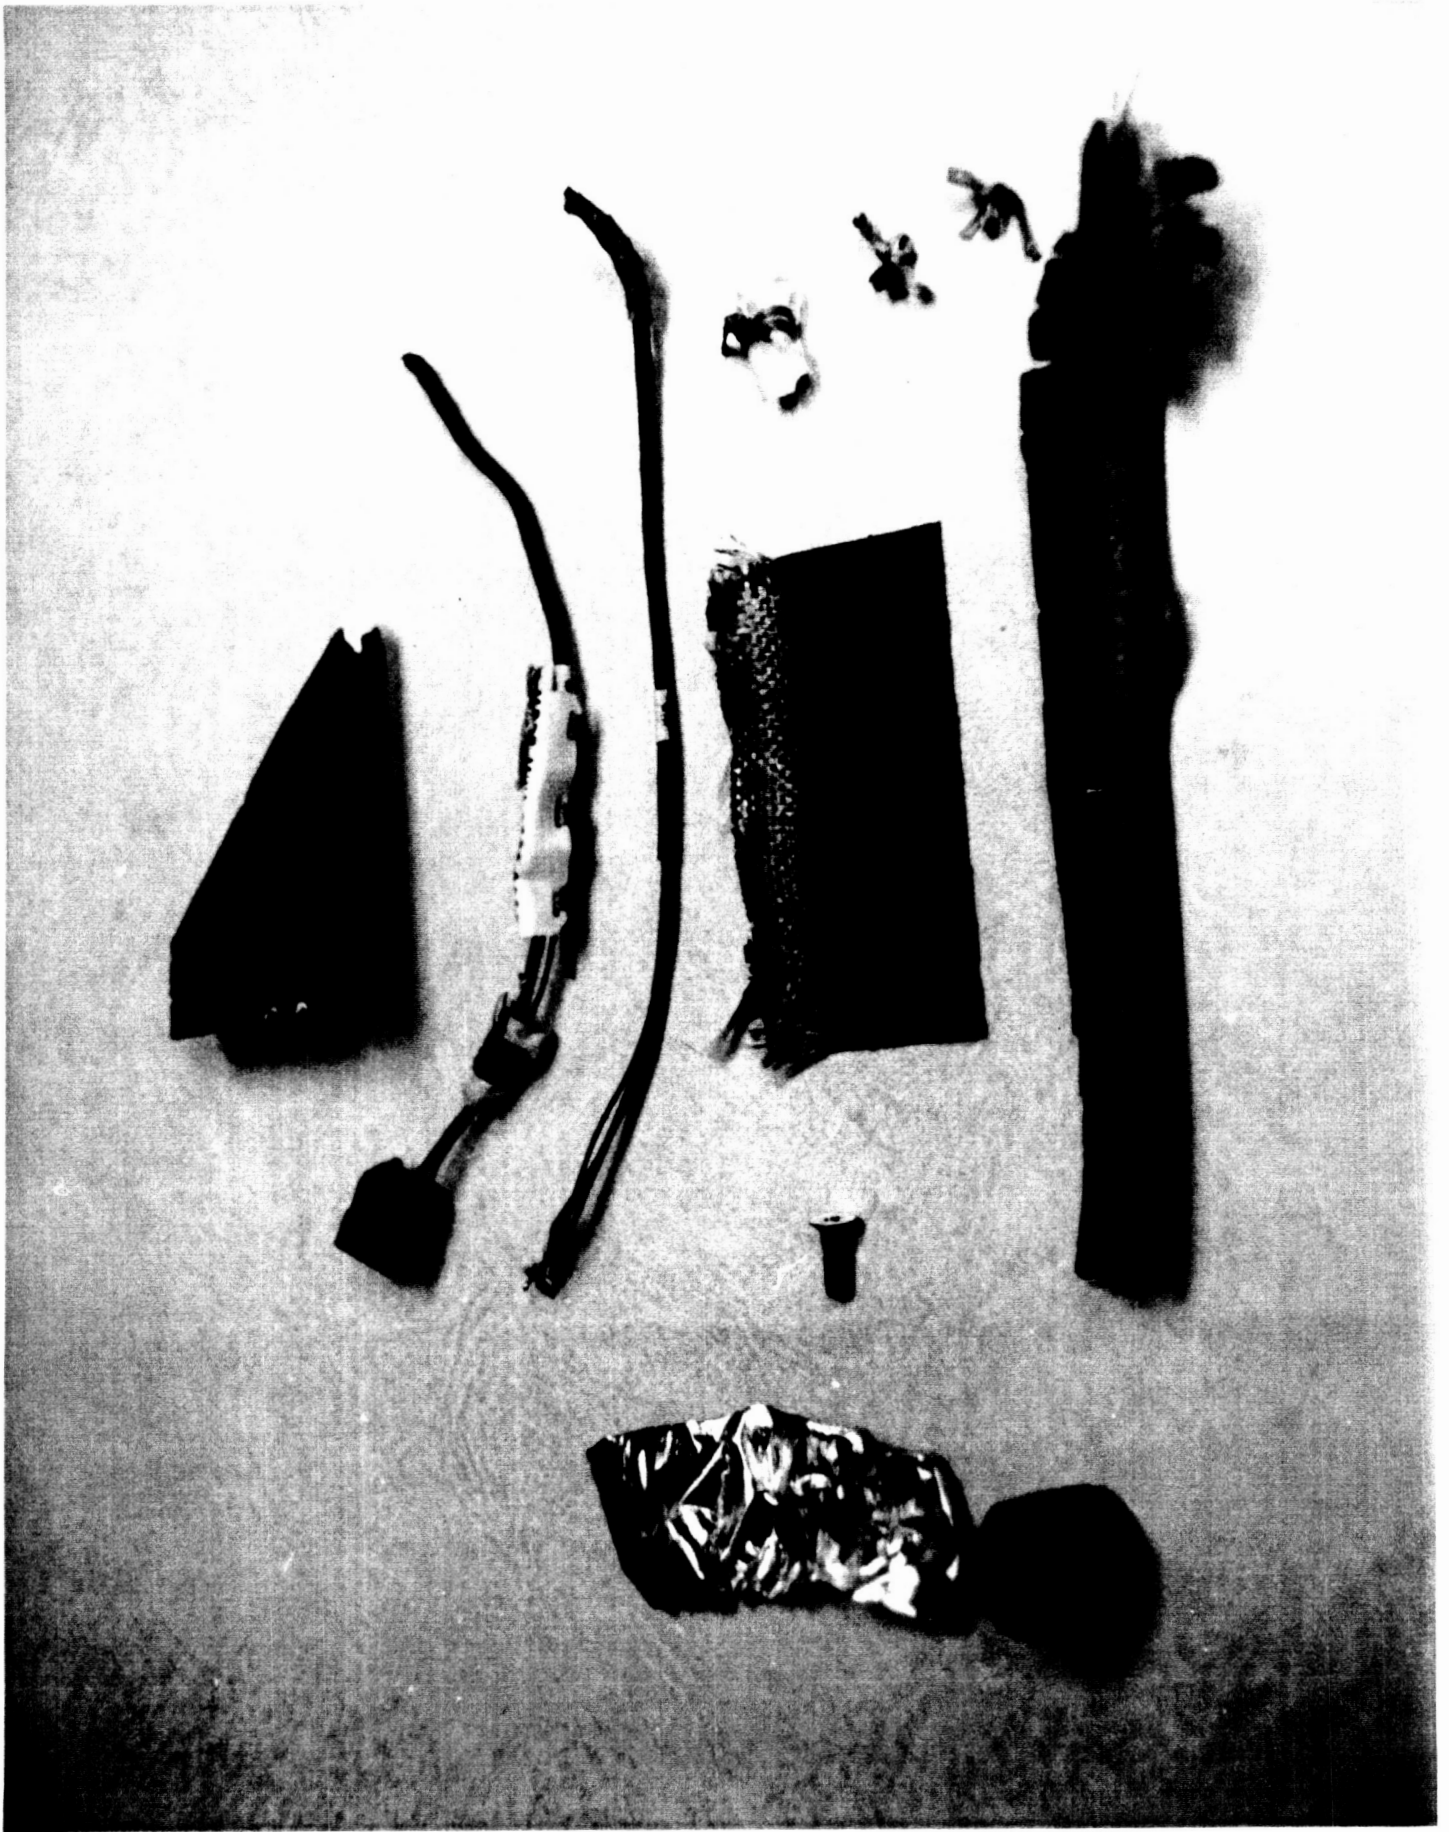
During the post landing runway walkdown, two 10" long pieces of wire, one with a connector attached, were found. These wires originated from the right main landing gear wheel pressure strain gage system. At touchdown, these wires broke loose from the wheel and were thrown up into the Orbiter tile, causing a gouge 1-1/8 inch deep. Post landing inspection of the vehicle revealed that the debris plunger in the RH (LO2) EO-2 separation fitting debris container failed to seat properly in the 2-1/2" hole at ET/ORB separation. The plunger was jammed by two large pyro nut fragments. Two of the three umbilical plungers also did not have total closure. A concentration of tile hits were located aft of the LH2 umbilical. Similar patterns have been observed on previous flights and have been attributed to umbilical ice particles released at ET separation.

HARDWARE COLLECTED DURING POST LANDING RUNWAY WALKDOWN. NOTE
TILE PIECE, AMES GAP FILLERS, AND WHEEL PRESSURE SYSTEM WIRES

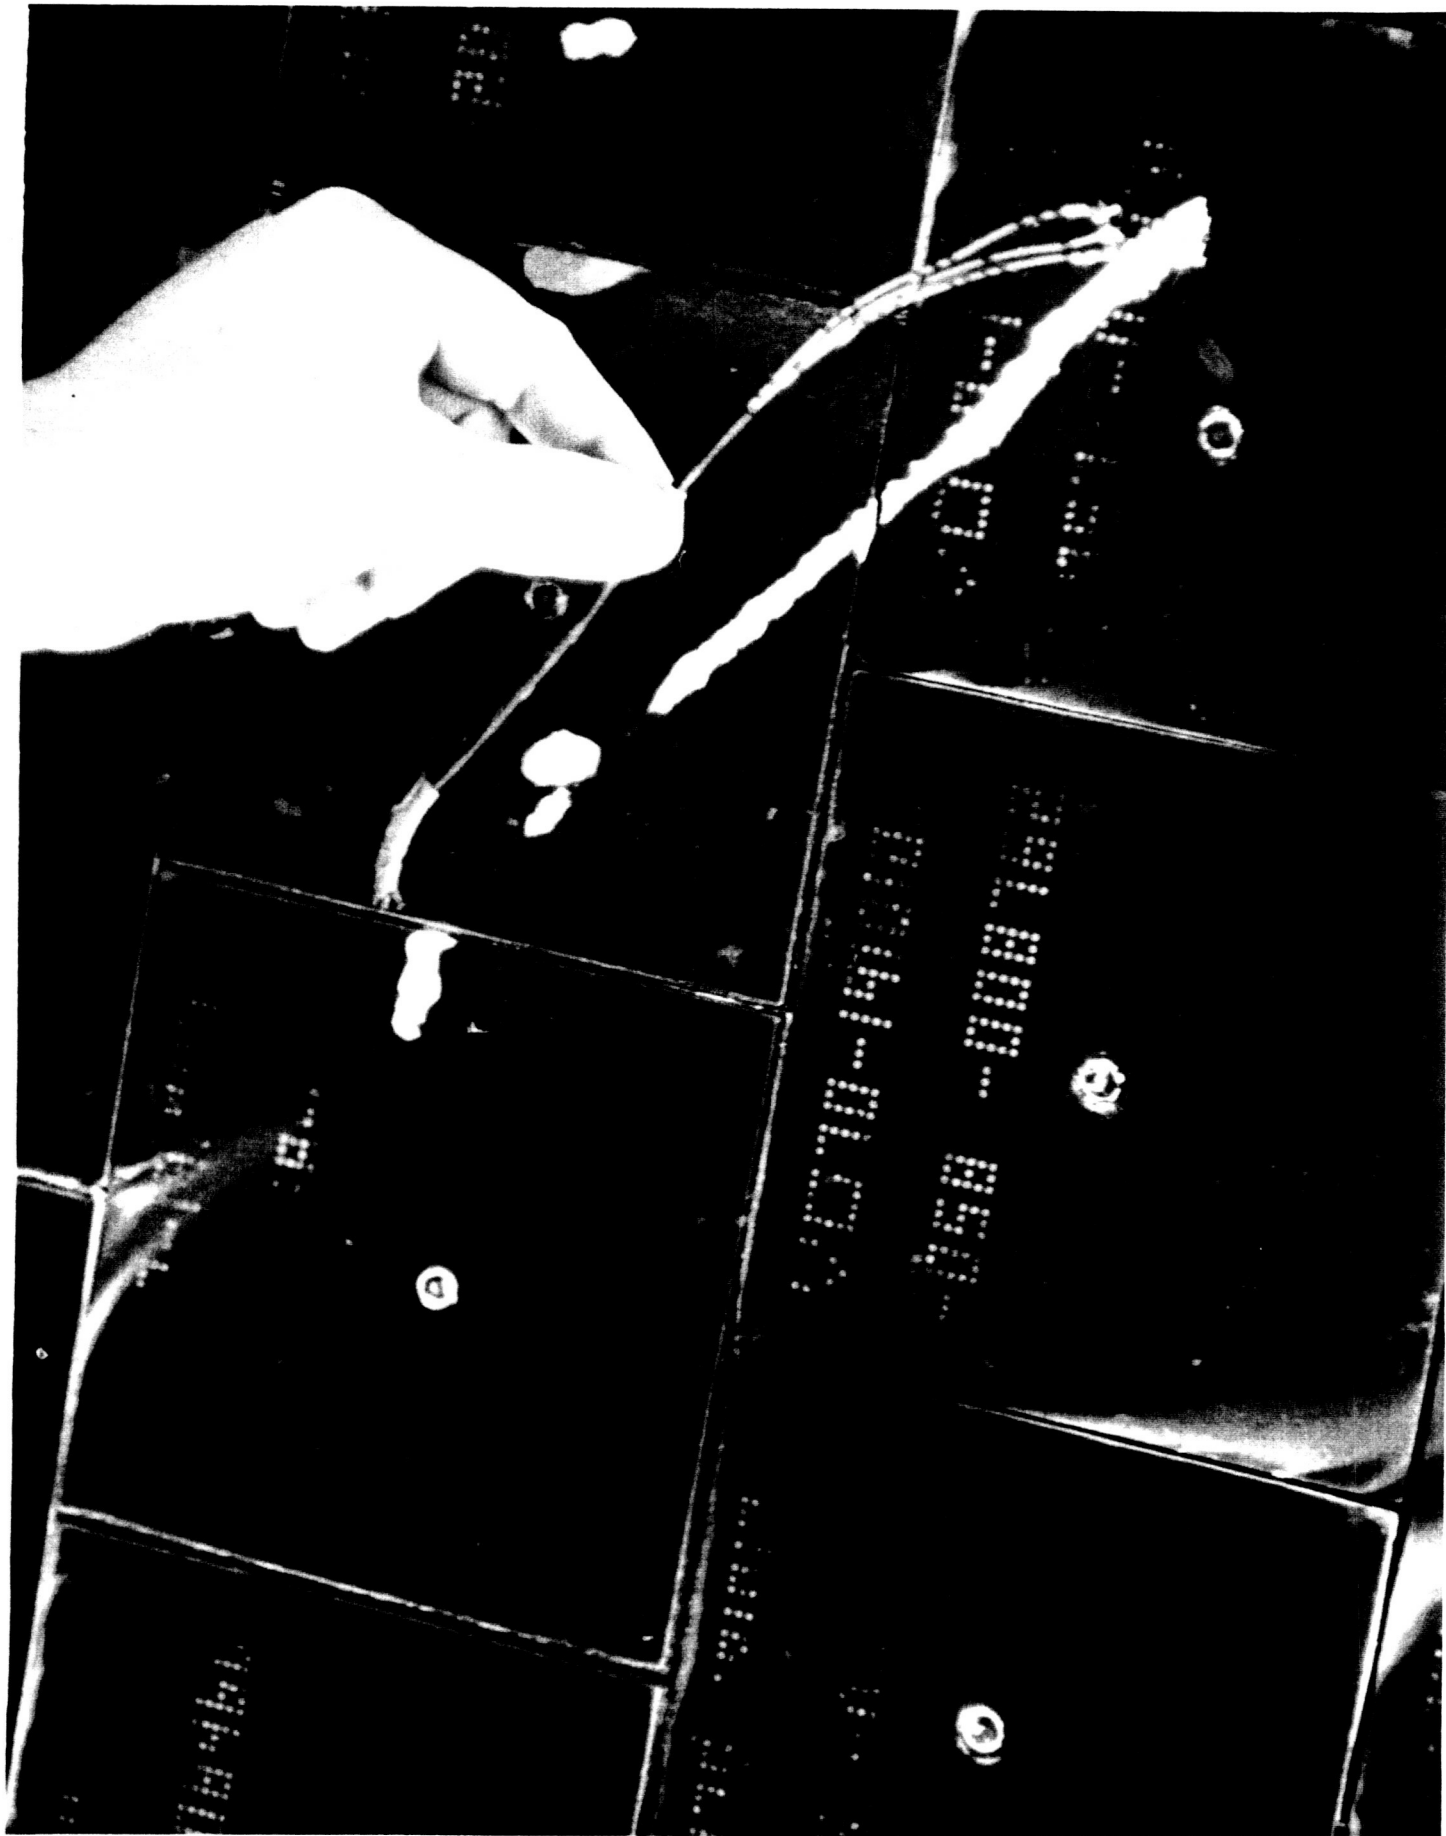
10-INCH GOUGE IN TILES AFT OF RH MLG DOOR DUE TO IMPACT
OF WHEEL PRESSURE STRAIN GAGE SYSTEM WIRE FOUND ON RUNWAY

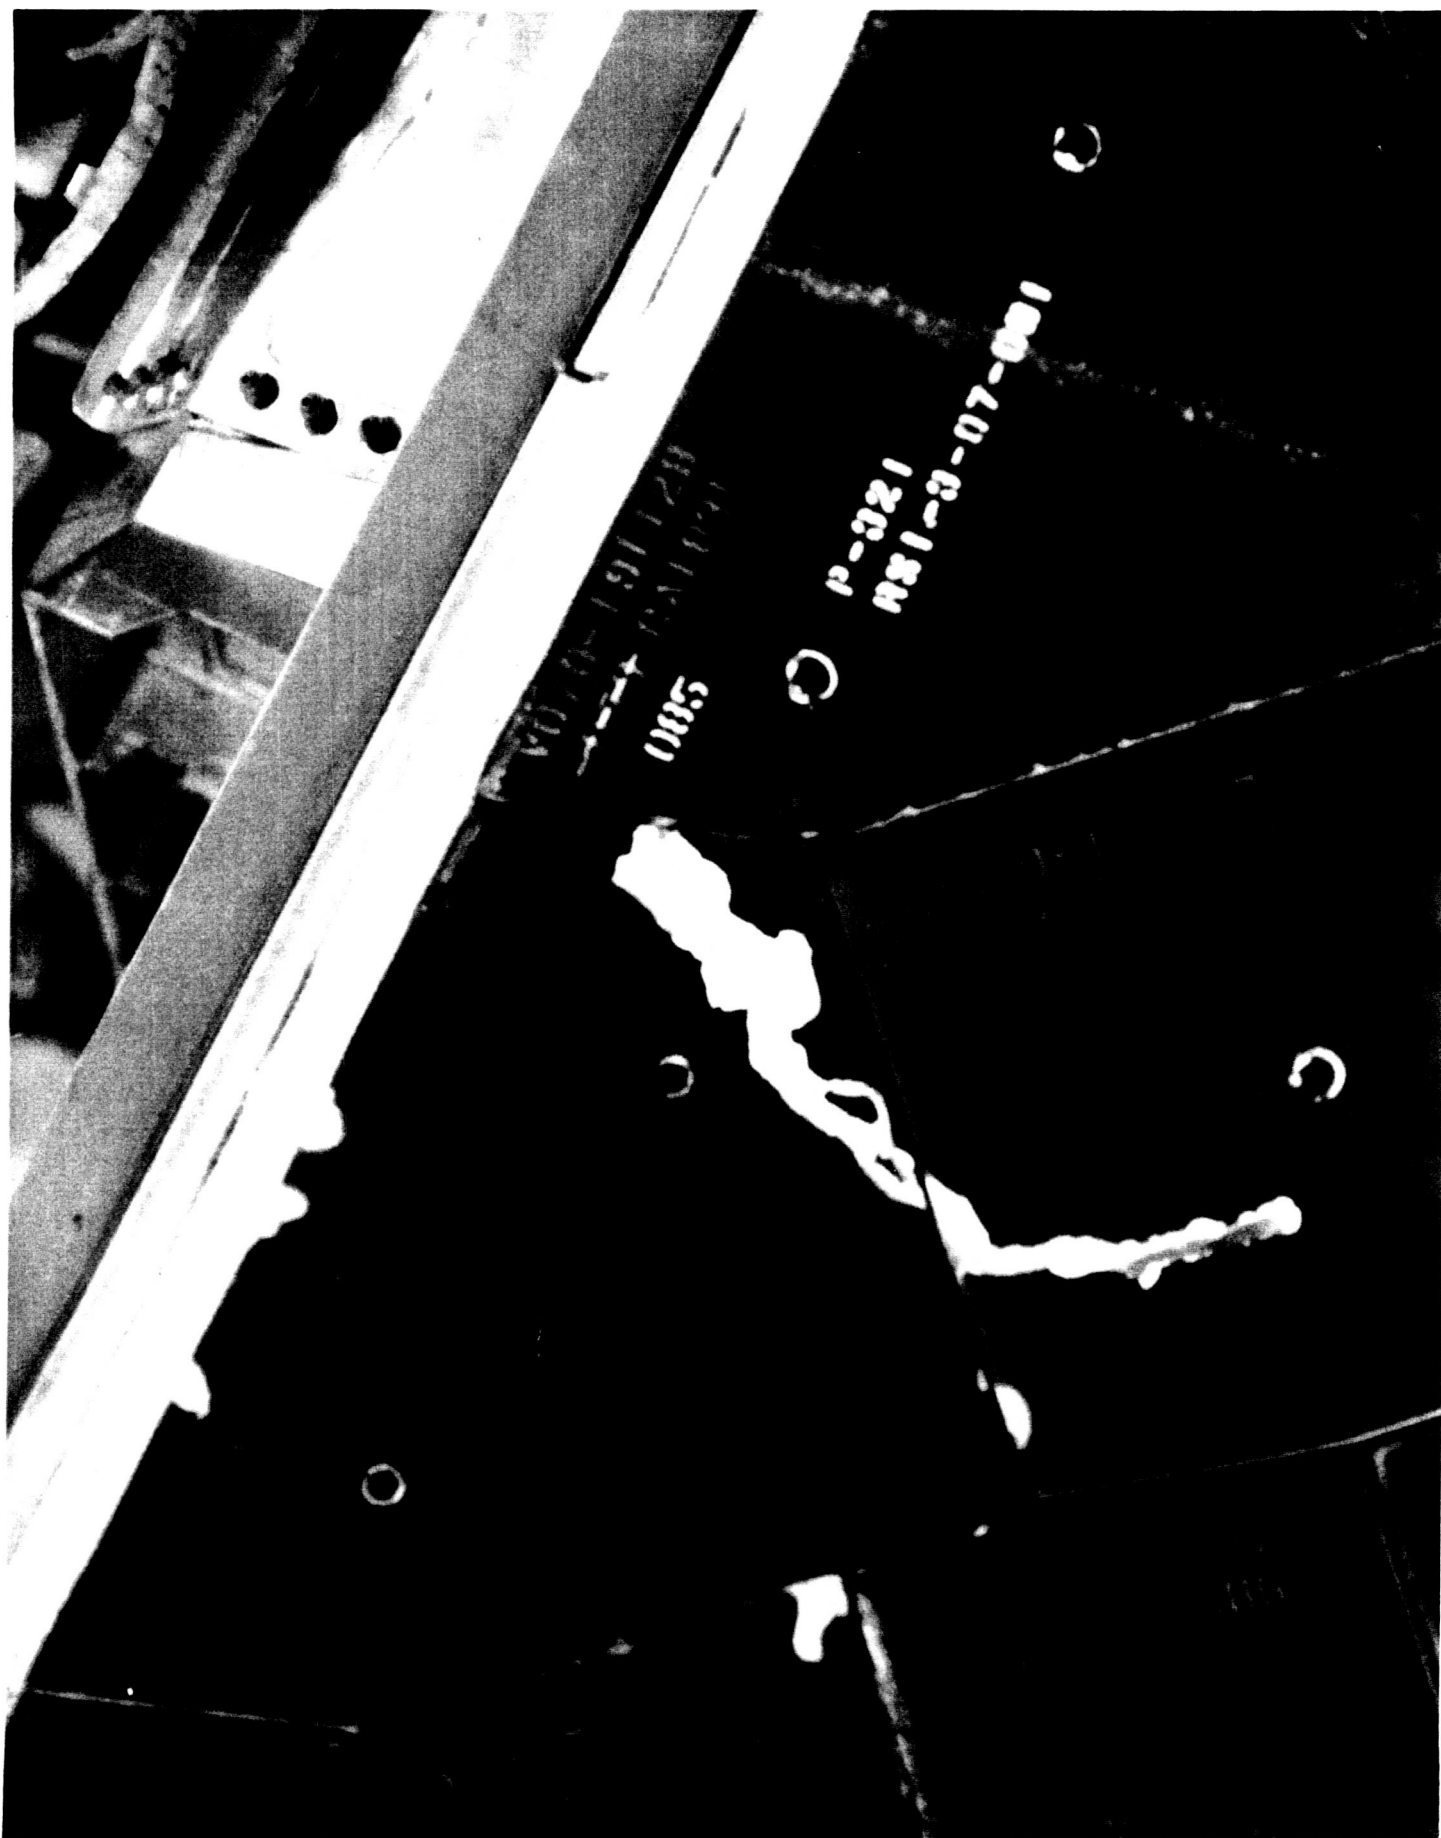
8"x1"x1-1/8" GOUGE AFT OF RH MLG DOOR DUE TO IMPACT OF WHEEL
PRESSURE STRAIN GAGE SYSTEM WIRE/CONNECTOR FOUND ON RUNWAY

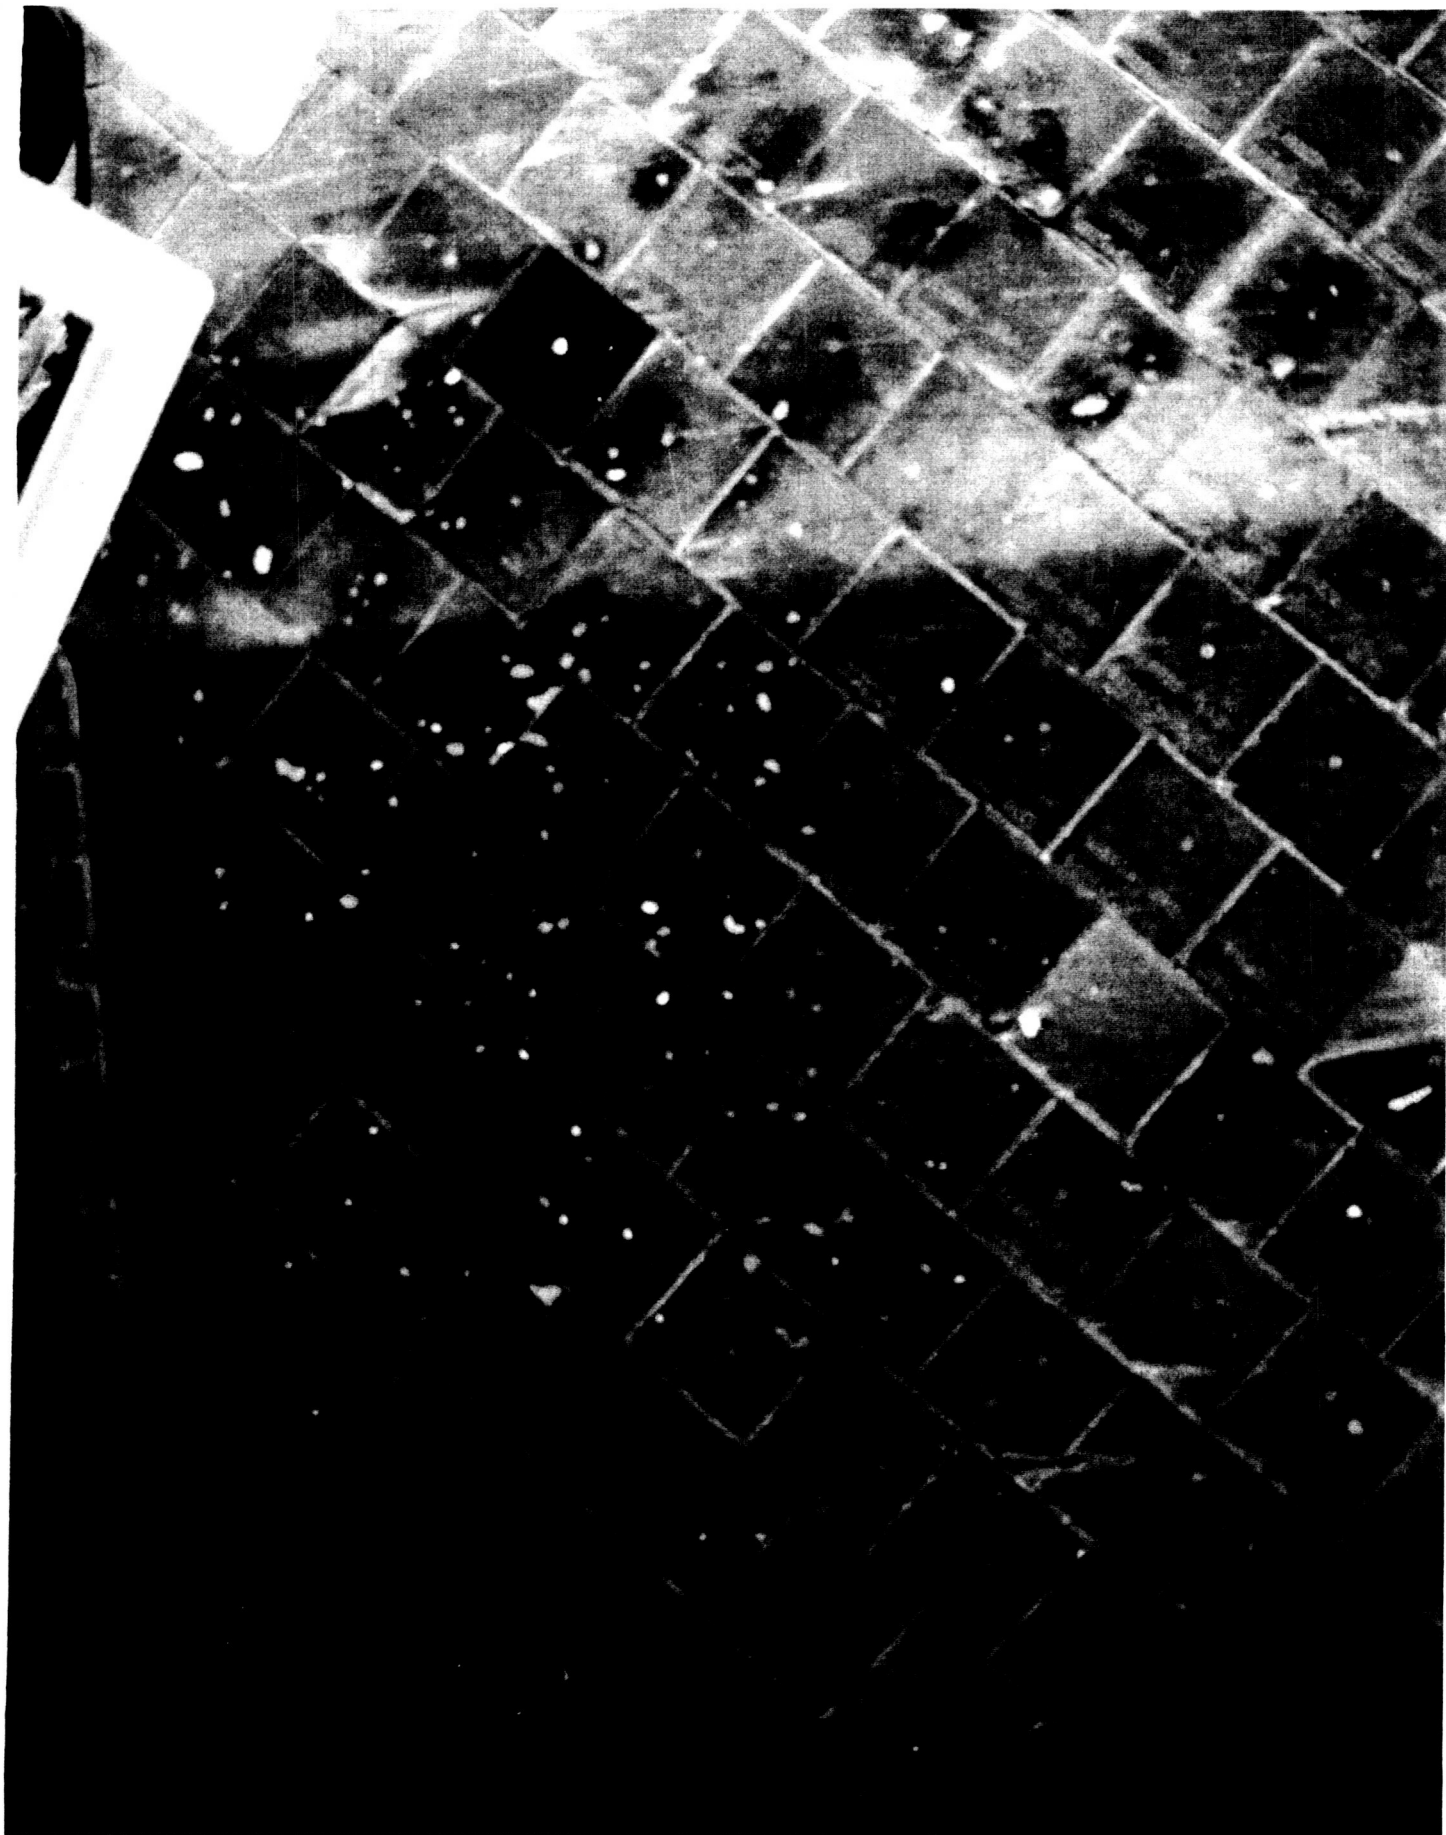
CLUSTER OF TILE HITS AFT OF ET/ORB LH2 UMBILICAL DUE
TO UMBILICAL ICE PARTICLES RELEASED AT ET SEPARATION

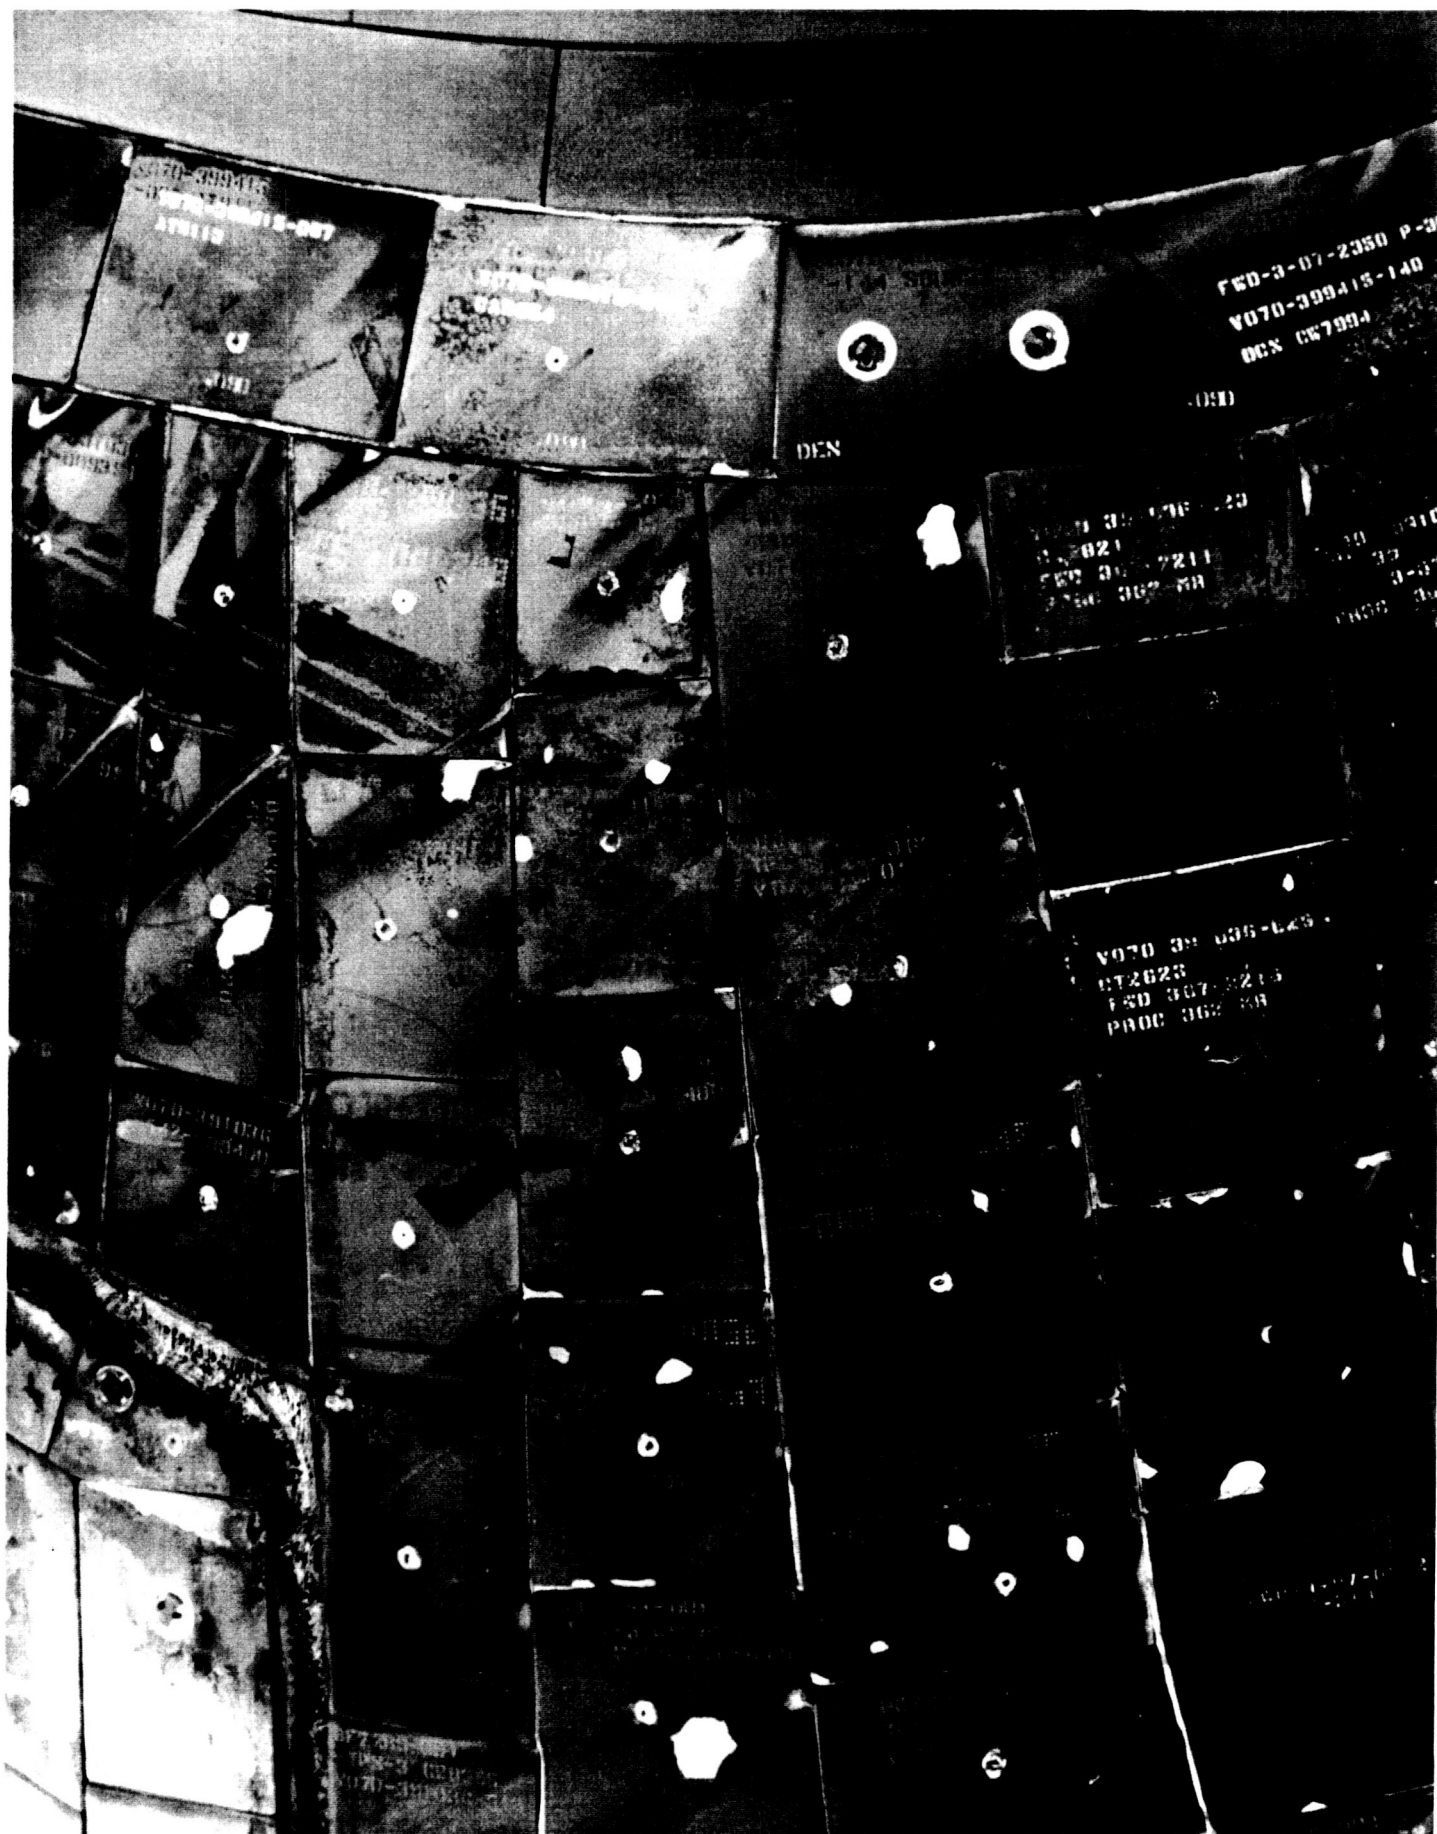
FUSELAGE TILE DAMAGE AFT OF ORBITER NOSE CAP

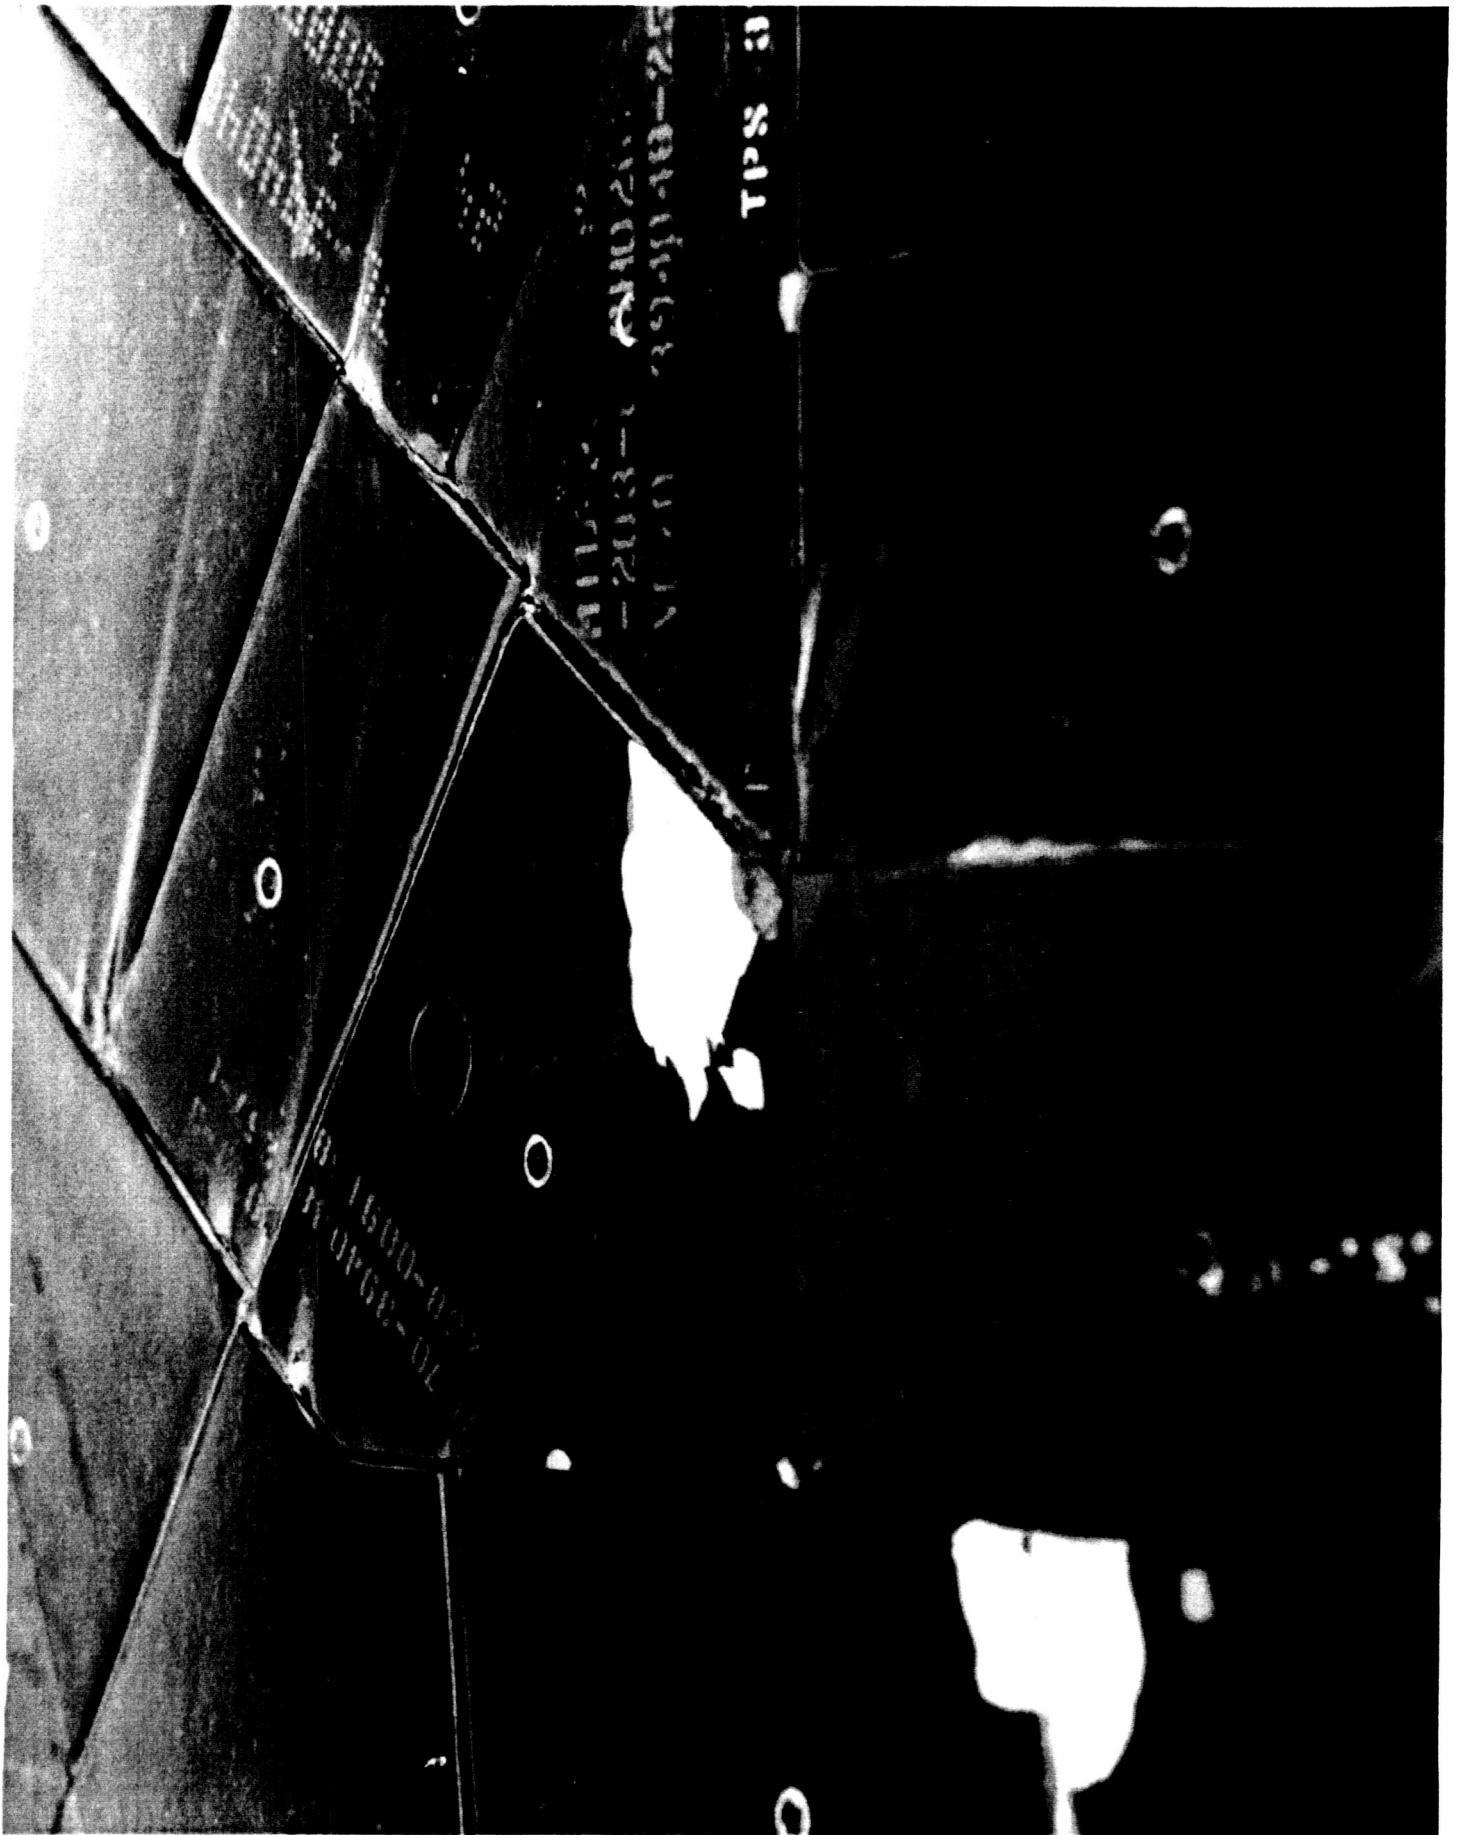
TYPICAL TILE DAMAGE FROM LOW DENSITY DEBRIS IMPACT

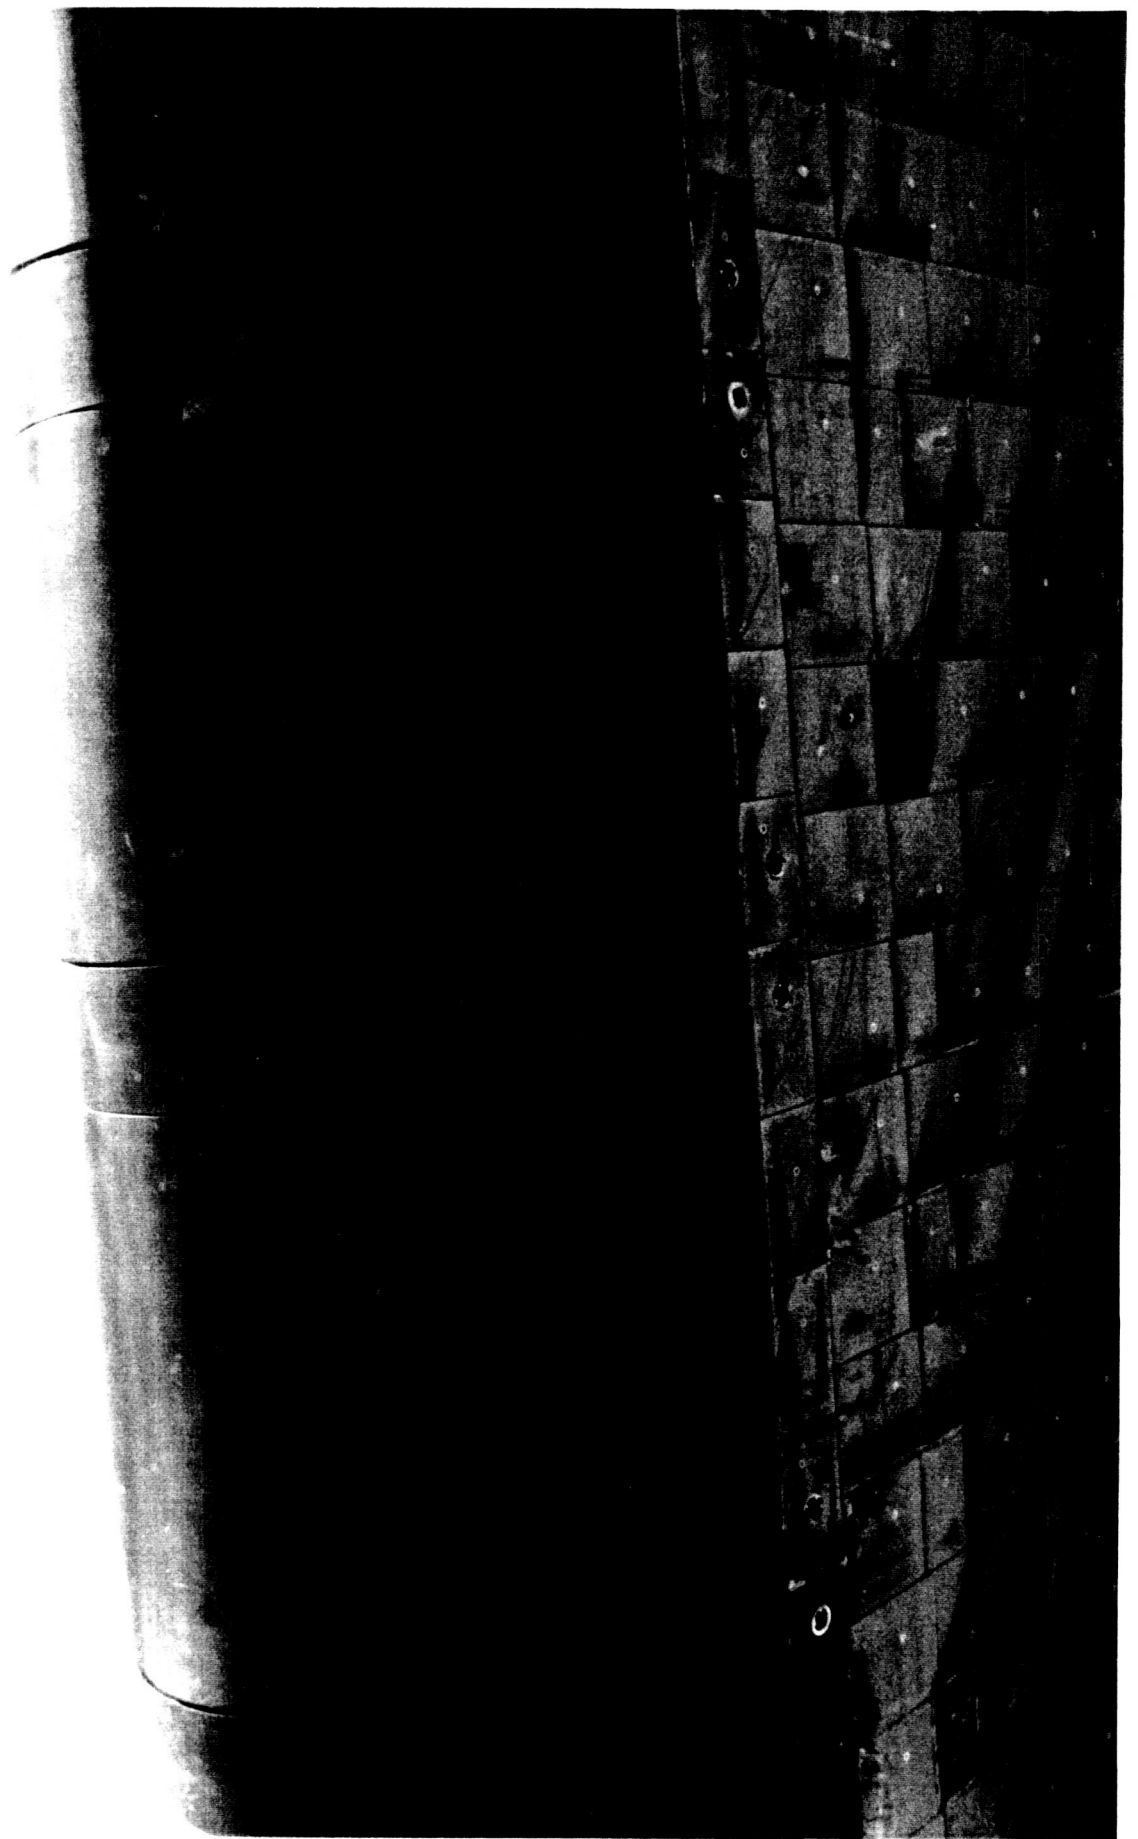
WHITE STREAKS ON WING LEADING EDGE RCC PANELS

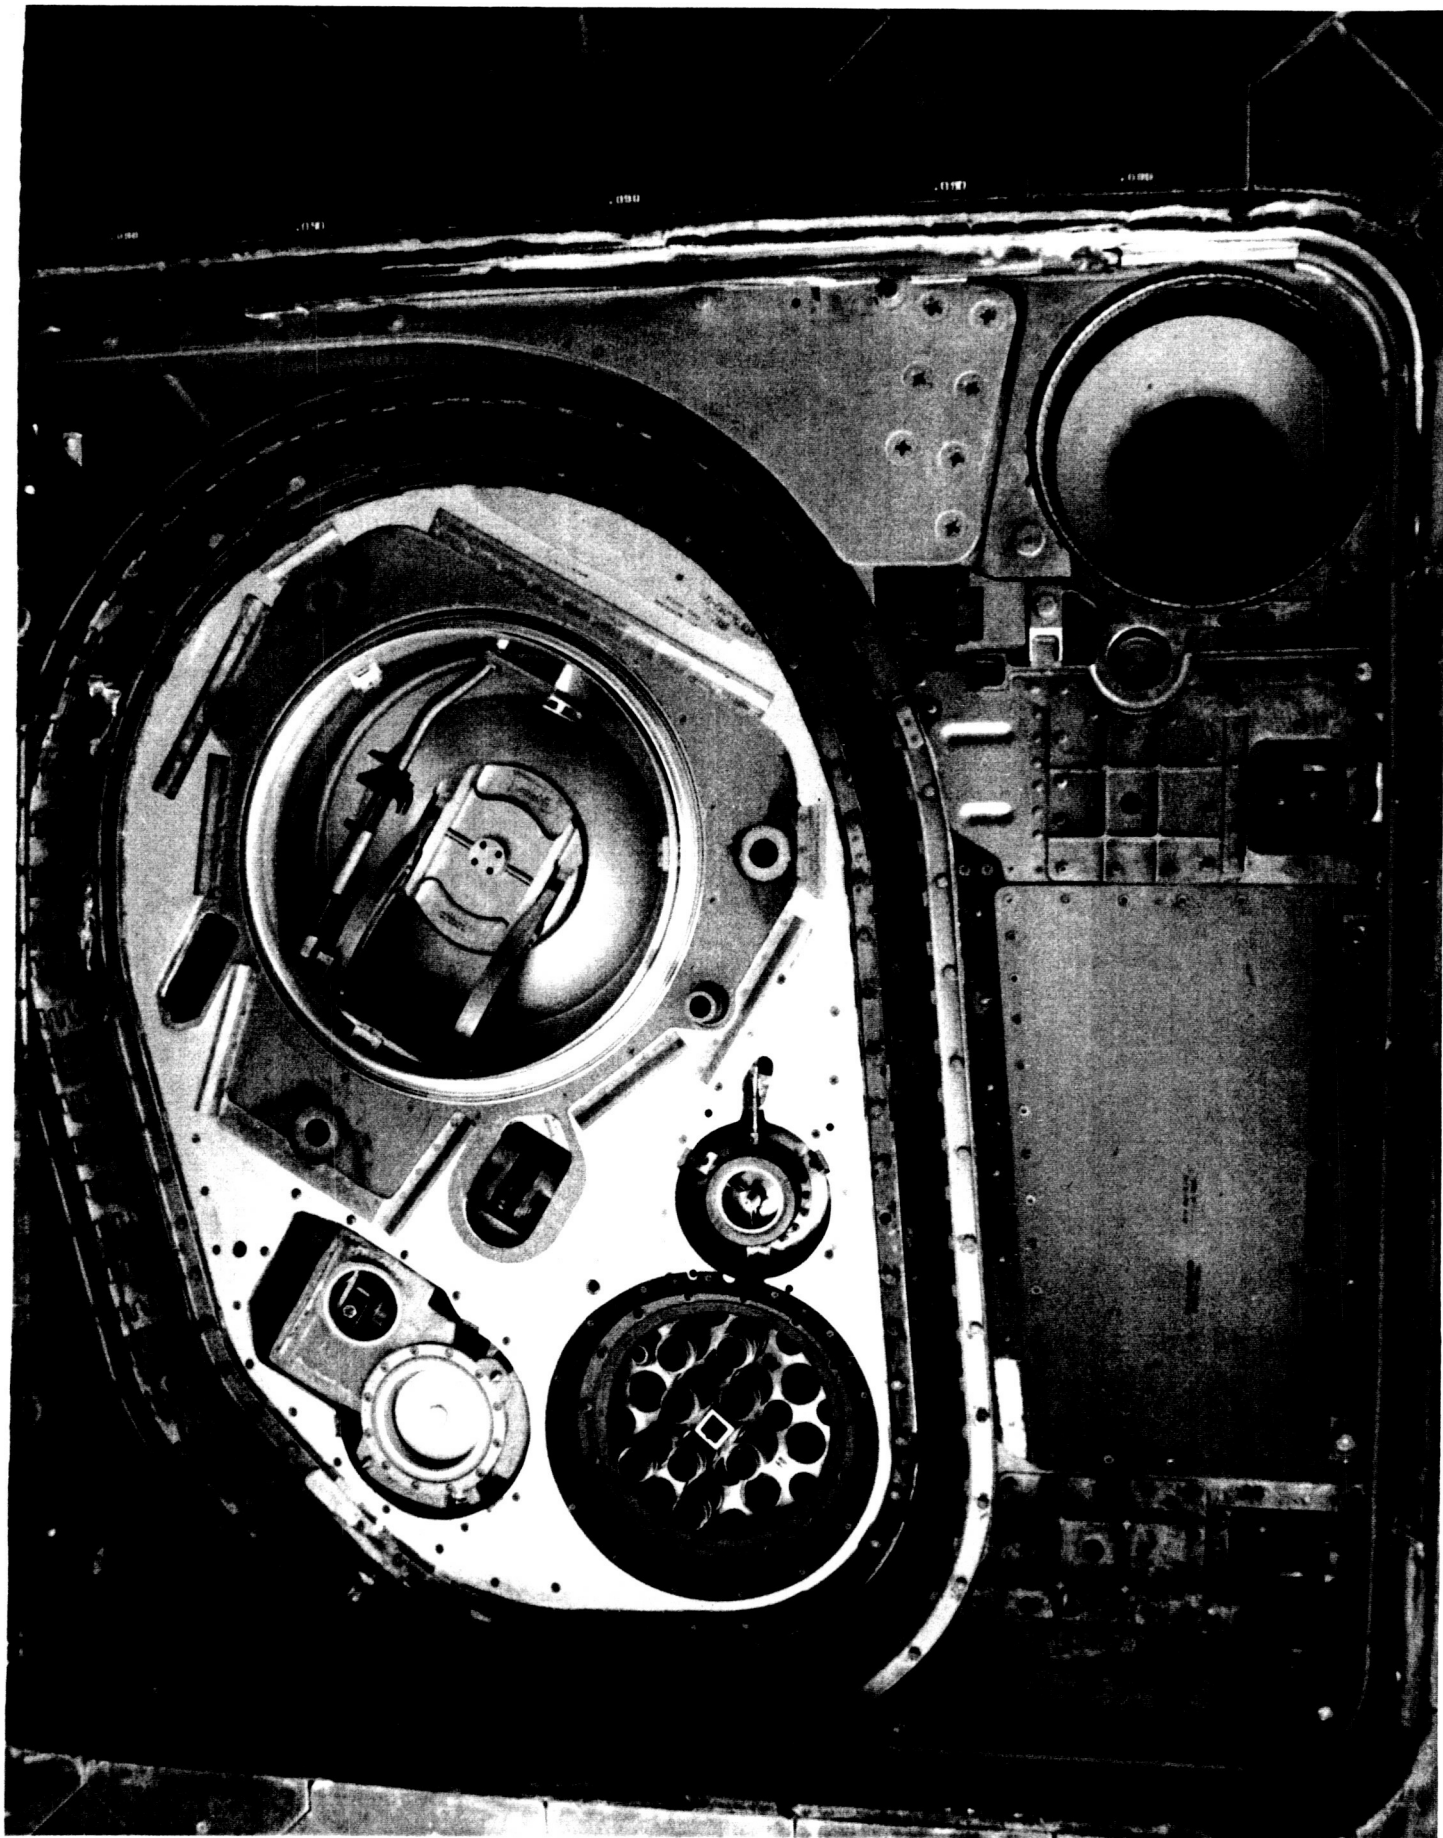
NO SIGNS OF DAMAGE TO CRYOGENIC SEALS THAT WOULD CAUSE THE
DENSE VAPORS TO EMANATE FROM LH2 UMBILICAL PRIOR TO LAUNCH
